## Smart Lander for Investigating Moon (SLIM)

### Results from the Moon Landing

Institute of Space and  
Astronautical Science  
SLIM Project Team  
Project Manager

## ► Today's report

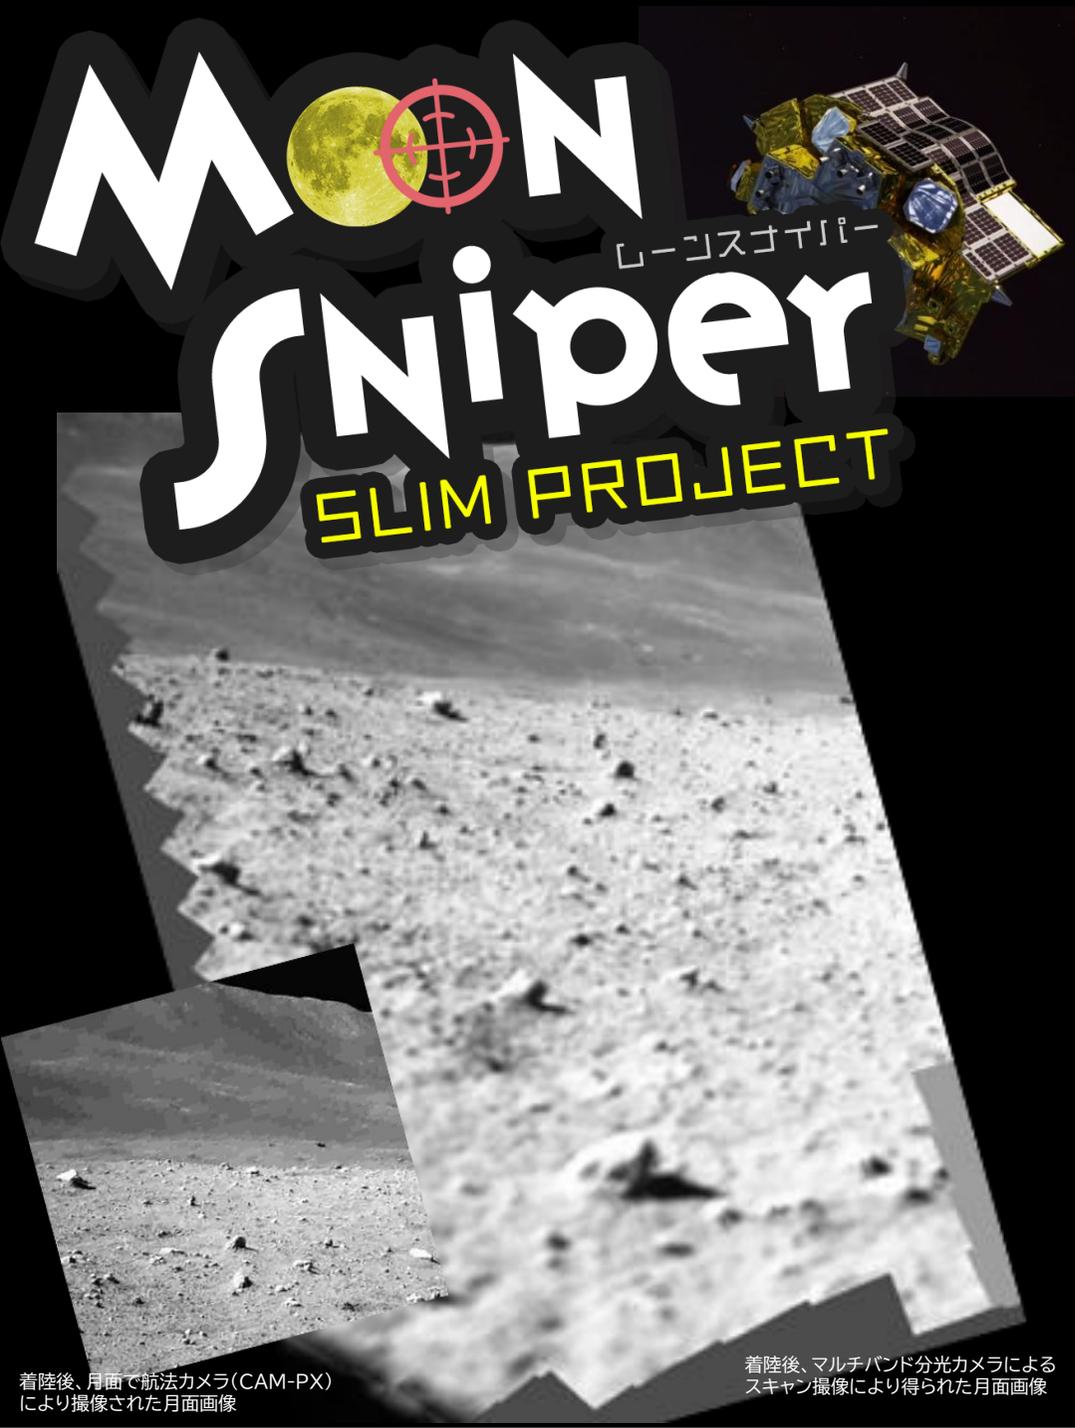
着陸後、月面で航法カメラ(CAM-PX)  
により撮像された月面画像

着陸後、マルチバンド分光カメラによる  
スキャン撮像により得られた月面画像

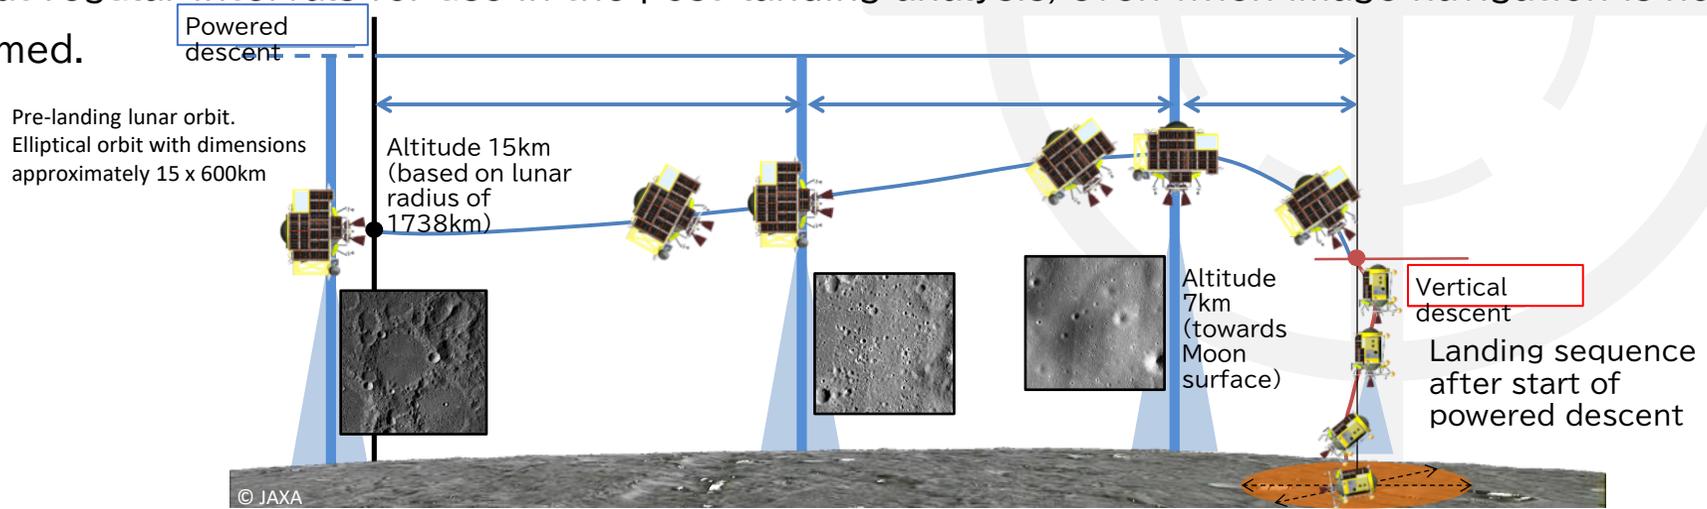
## ► Outline of landing sequence

1. Initiate the landing descent from lunar orbit and approach the target site on the lunar surface through **autonomous navigation and guidance control**, while precisely estimating the current position using **image-based navigation with the navigation cameras**.
2. From above the target site, precise measurement of altitude and terrain-relative velocity conducted using the landing radar that is integrated into the navigation guidance system.
3. Image-based obstacle detection is performed at approximately 50m above the landing site and landing is performed autonomously, avoiding hazardous boulders and other obstacles. That is, pinpoint landing is prioritised up to 50m above the surface, after which obstacle avoidance is prioritised for landing safety.

[Note] Spacecraft position and velocity are propagated by the onboard accelerometers and corrected to higher accuracy by image-based navigation. Additionally, the navigation camera images are also taken at regular intervals for use in the post-landing analysis, even when image navigation is not being performed.

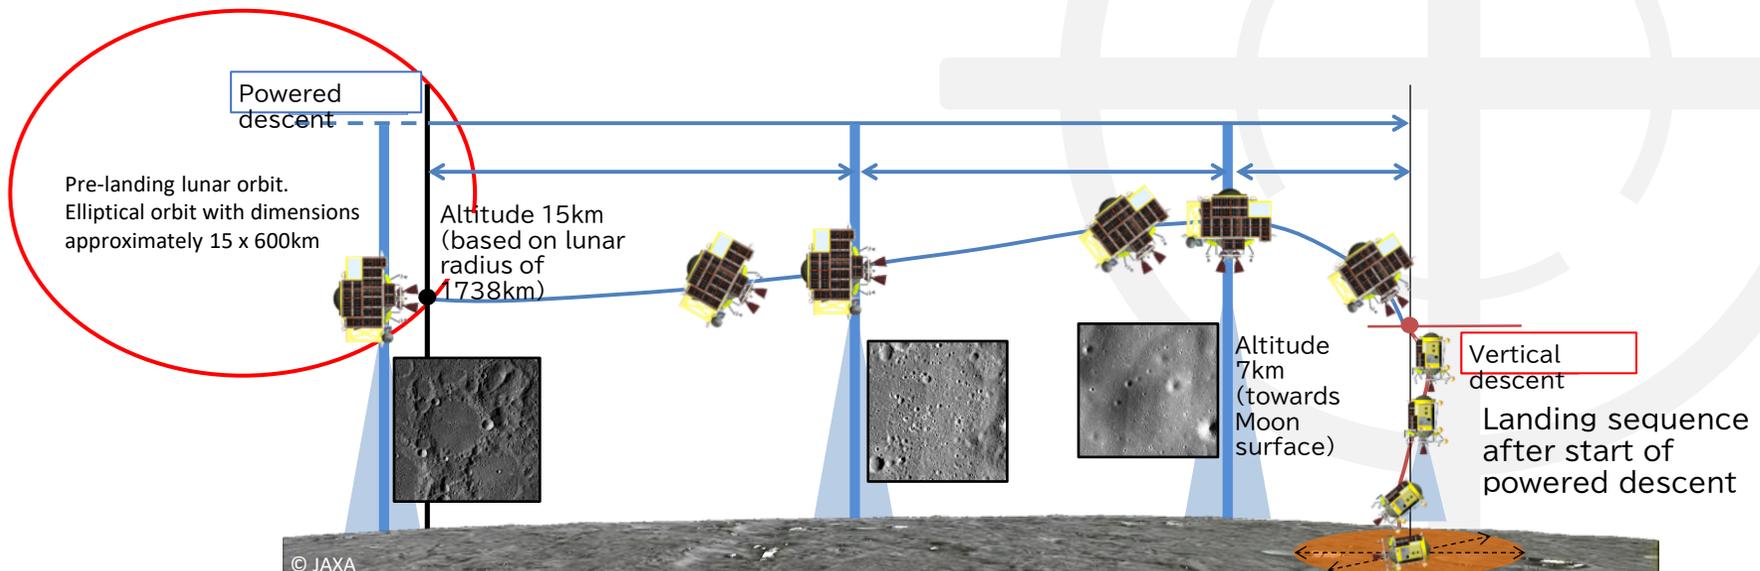
[Before the start of the landing descent]

- Prior to the start of the powered descent, image matching navigation was performed in three areas (1/19 23:52:43, 23:54:43, 23:56:45 JST)
- All image matching was successfully completed twice in each area, and orbit correction (guidance calculation) on the spacecraft from the results was successful. The final decision to begin landing descent was therefore made (at around 23:59 JST).
- The main engines began to fire as planned, and the powered descent phase, the first half of the landing descent sequence, began (23:59:58 JST)

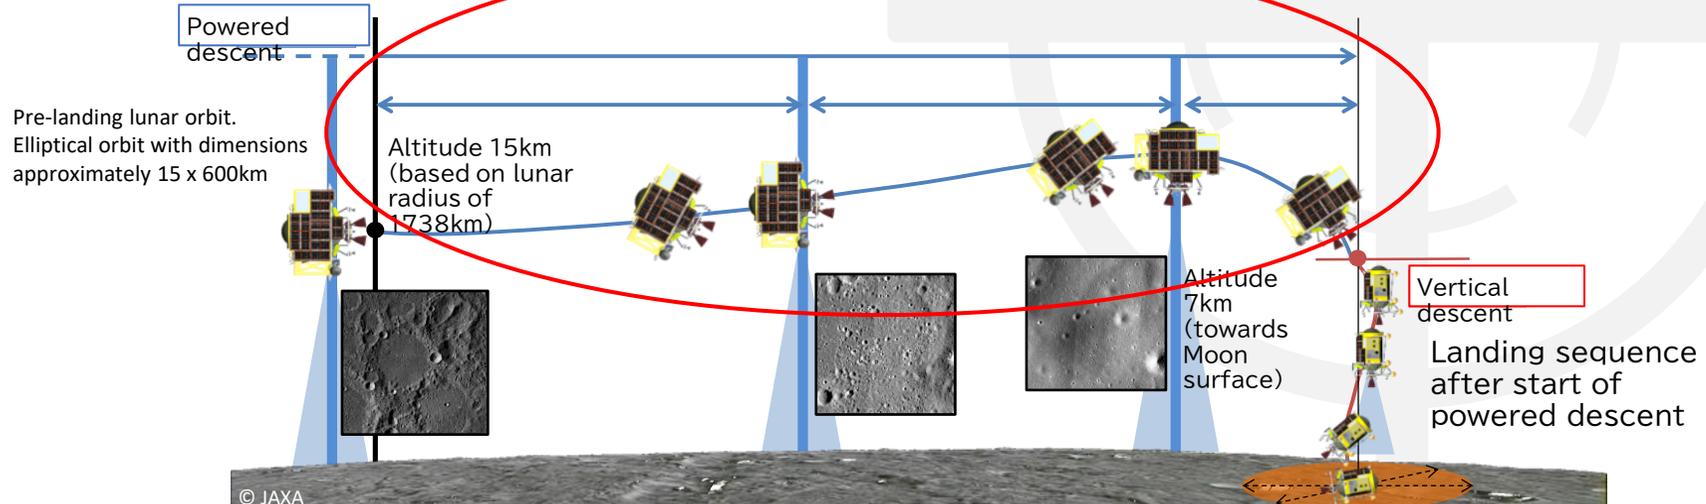
[During the powered descent phase]

- After the start of the powered descent, the spacecraft descended almost in line with the planned trajectory.
- During the powered descent phase, image matching were performed twice in each of two areas, both completed successfully. In the first area, a position correction of approximately 200m altitude / 100m horizontal position was applied, and in the second area, a position correction of about 1km altitude / 200m horizontal position was applied. This was immediately reflected in the planned trajectory from the guidance recalculation.
- At the end of the powered descent phase, the spacecraft was at an altitude of approximately 6.2km as planned, with a good horizontal position error of less than about 100m. The vertical descent phase then began.

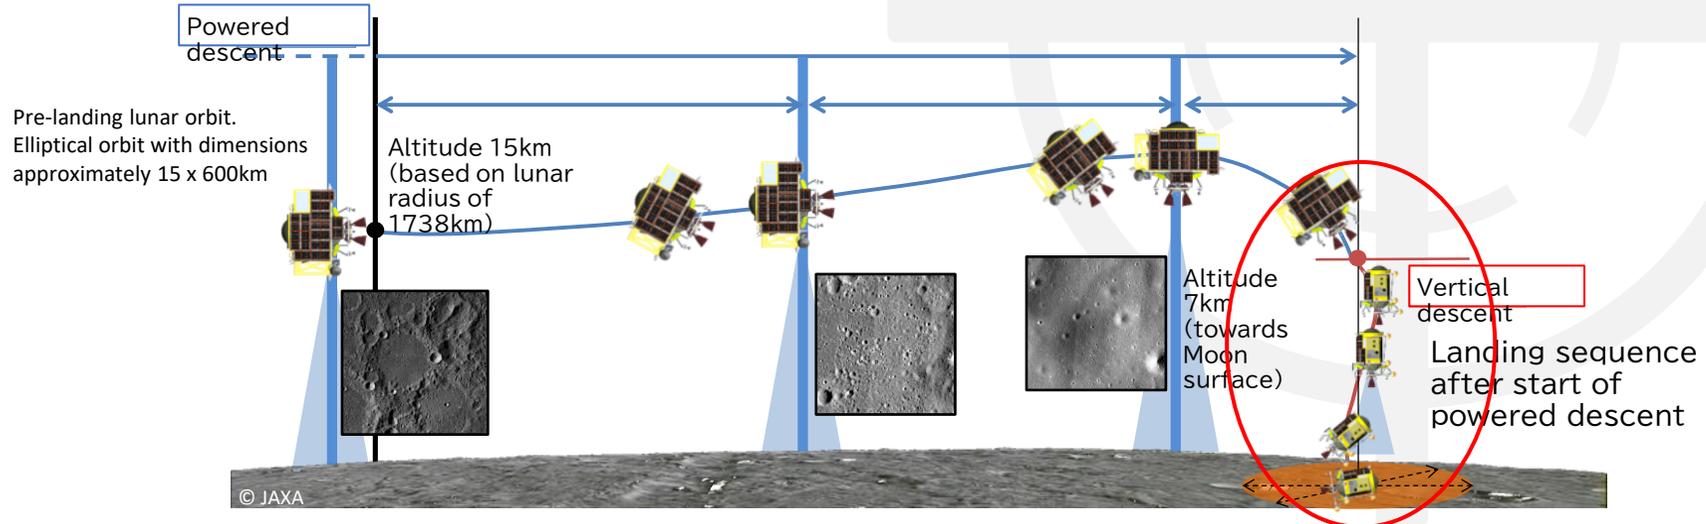
[During the vertical descent phase]

- After entering the vertical descent phase, altitude measurements by the landing radar were successfully initiated.
- Image matching was performed twice each at an altitude of approximately 4000m and 500m, and this was successful. The amount of horizontal position correction was about 100m and 50m, respectively, and the resulting position correction control was also successfully implemented.
- At an altitude of 50m, image-based obstacle detection was also successfully performed, and the spacecraft autonomously identified the safest location in the image, which was then used at the final landing target.
- Based on this information, we believe that the landing descent to an altitude to 50m was very good.

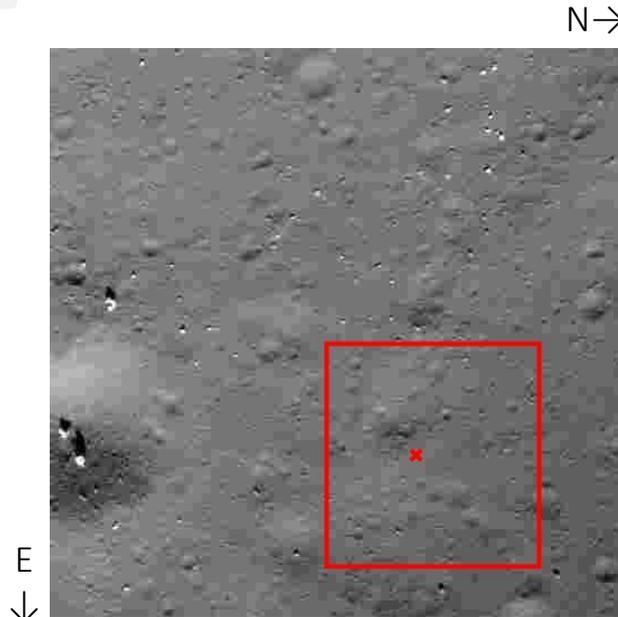
Obstacle detection #1 results  
(Red dots. Red box is the spacecraft footprint including guidance errors)

※ images squiared from the SLIM navigation camera (CAM-MZ)

- Obstacle detection was performed twice, both times completed successfully.
- The images used for detection were later evaluated and all the sites chosen are believed to have been relatively safe.
- The result from the second detection was adopted for the final landing target (about 12m east-southeast from the previously set landing target)

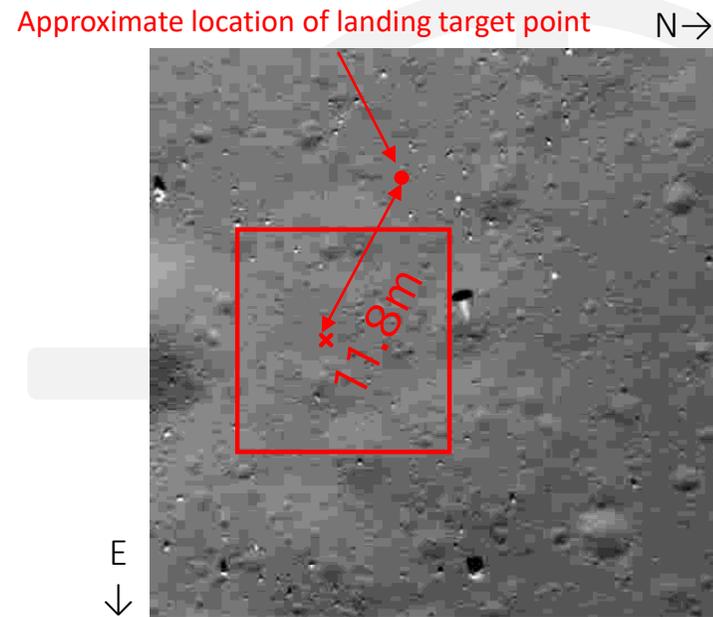
Obstacle detection #2 results  
(Red dots. Red box is the spacecraft footprint including guidance errors)

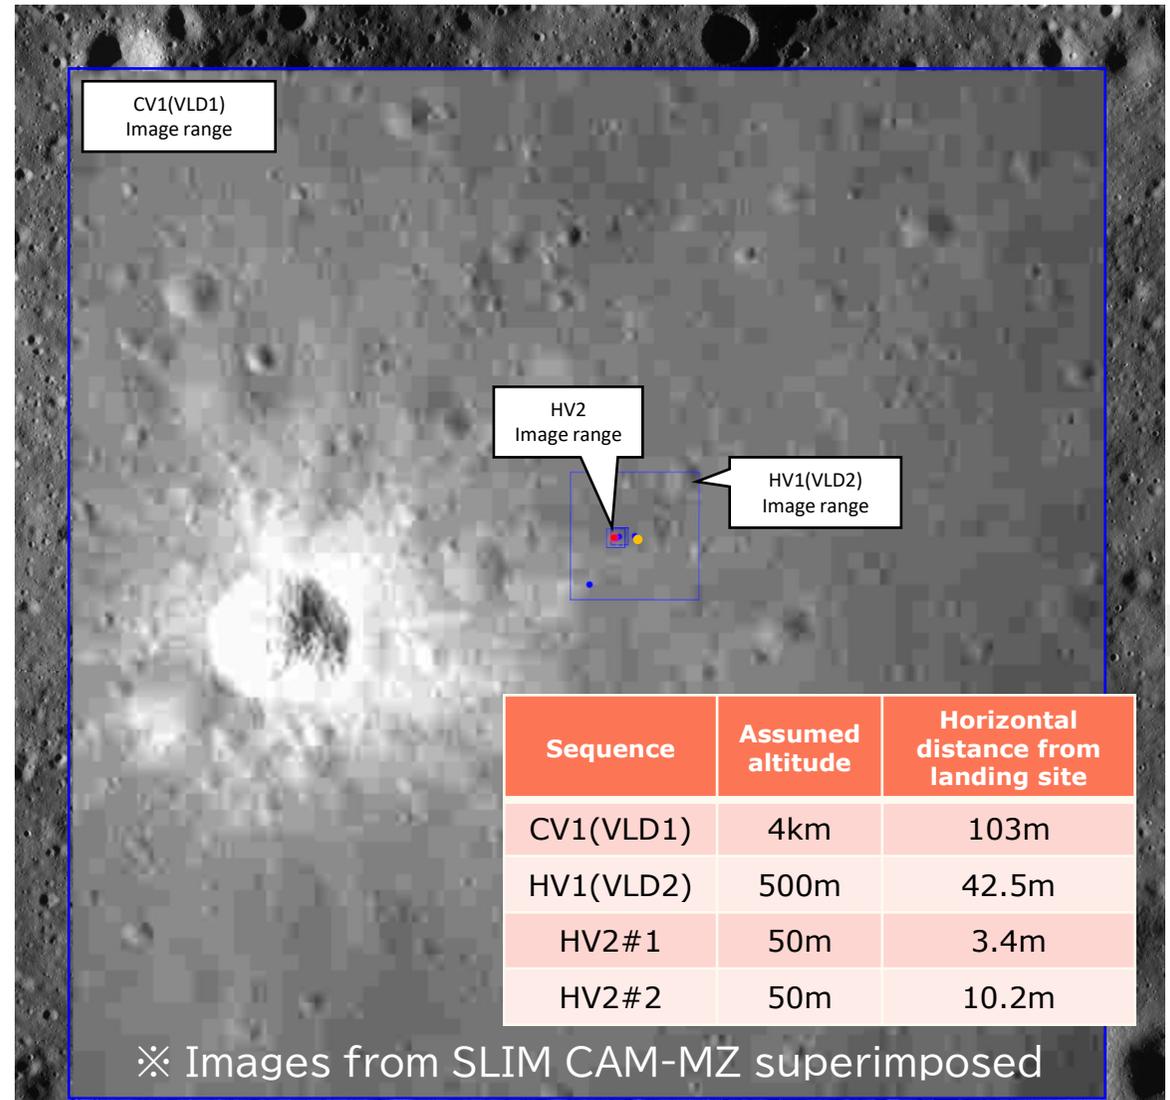
- The evaluation was conducted using images from Chandrayaan-2, which has relatively high resolution and was also used in the selection of the landing target site.
- Specifically, the task was to find features in the Chandrayaan-2 image in common with the navigation camera image and identify the area where the two images overlapped.
- The right figure shows the situation at two altitudes (CV1, HV1) and during obstacle avoidance (HV2). The central blue dot and the red dot is the target landing site selected prior to launch.
- As the altitude drops and the spacecraft approaches the lunar surface, the centre of the field of view of the navigation camera gradually approaches the target landing site, as a result of the navigation guidance control.

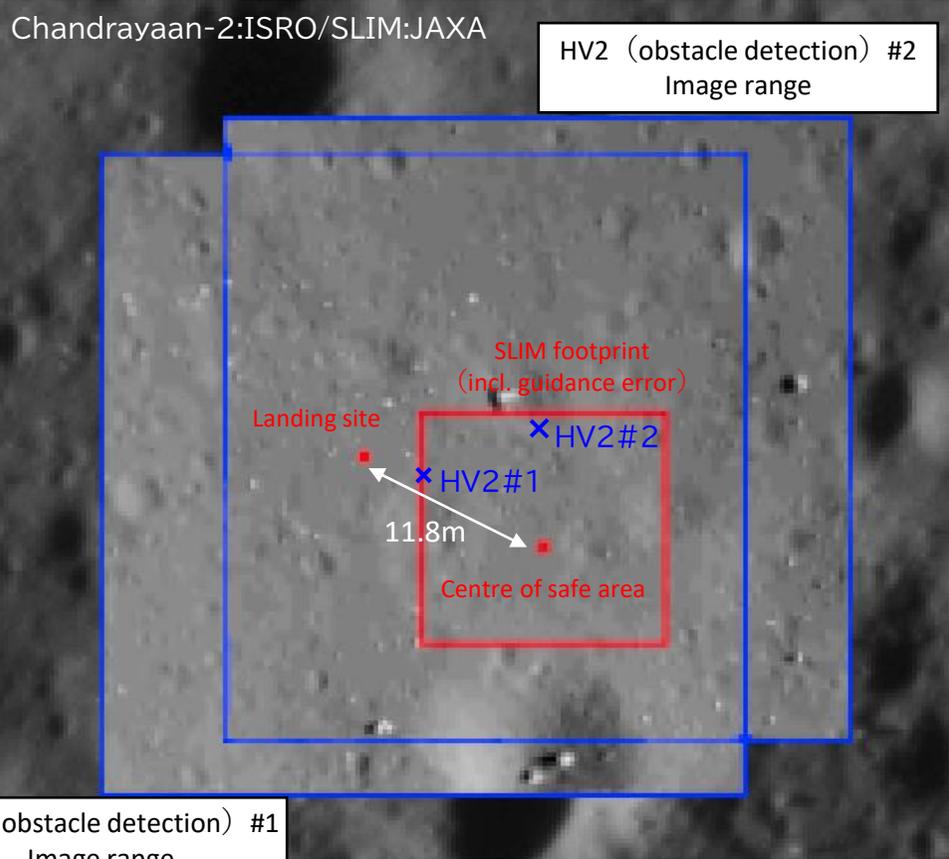
- Lower right figure shows an enlarged view of the vicinity of the image for obstacle avoidance. Blue dots indicate the centre position of the first (#1) and second (#2) image capture (blue box), which corresponds to the horizontal position of SLIM, and its distance from the target landing site is shown in the lower right table.
- From the figure, it was estimated that the positional accuracy during the obstacle detection is estimated as about 3 ~ 4m for #1 and 10m for #2.
- As mentioned above, after this altitude, the landing target position was reset with priority given to landing safely (obstacle avoidance). Therefore the pinpoint accuracy is estimated to be approximately 10m or less.
- Furthermore, #2 is highly likely to have already drifted eastwards due to the abnormal event described below, and the actual pinpoint accuracy is likely to have been about 3 ~ 4 m.

Sequence	Assumed altitude	Horizontal distance from landing site
HV2#1	50m	3.4m
HV2#2	50m	10.2m

After obstacle avoidance, landing is aimed at the centre of the safe area in the diagram. Safety is now prioritised by selecting to avoid obstacles ahead of accurately landing at the target site (the spacecraft therefore aimed at a site 11.8m away from the target site). Pinpoint landing accuracy is therefore evaluated before the obstacle avoidance.

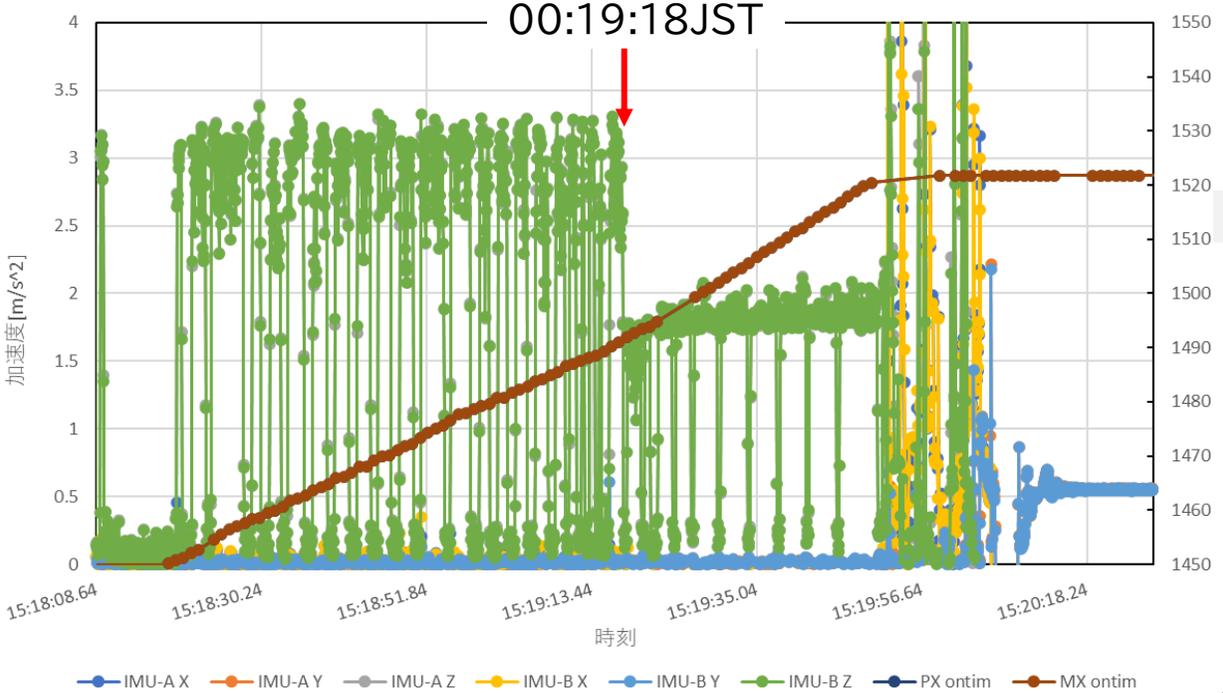
- The brown line is the accumulated injection time of the main engine, and the green line is the acceleration measured by the accelerometer, which detects the acceleration generated by the injection of the two main engines.
- Although the injection instruction to the main engines remained almost constant, the total thrust generated as measured by the accelerometer suddenly dropped to about 55% after 00:19:18.

- The spacecraft descended smoothly to an altitude of approximately 50m, but close to this point, an abnormality occurred in the propulsion system.
- Specifically, at around 00:19:18, the total thrust generated by the two main engines suddenly decreased to about 55%.
- Examination of the temperature behaviour after landing revealed that the -X side of the two main engines was not exhibiting the expected temperature increase (propellant value temperature rises due to heat soak-back).
- It is therefore likely that an abnormality occurred in the -X side main engine at this altitude.

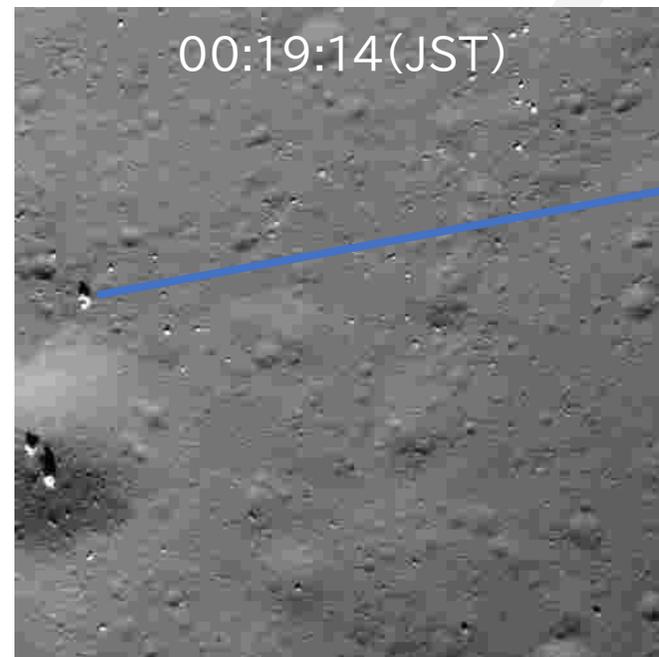
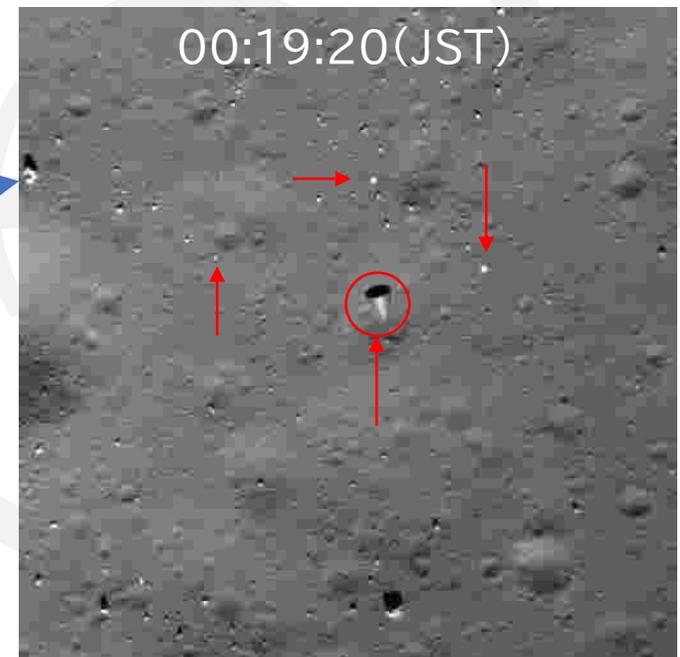
- ▶ Two navigation camera images taken near the time of the abnormality are shown below
- ▶ Immediately after the abnormality in the main engine thrust, the navigation camera images show spots of light and objects that had not been seen in the previous image
- ▶ Since one of these has a nozzle-like shape, it is assumed that some kind of abnormality occurred near the main engine on the  $-X$  side at around 00:19:18, causing the nozzle to break and fall, resulting in the loss of most of the thrust generated by the main engine on the  $-X$  side

- ▶ The blue arrow indicates the corresponding feature in both images
- ▶ The red arrows show spots of light or objects not seen in the left image

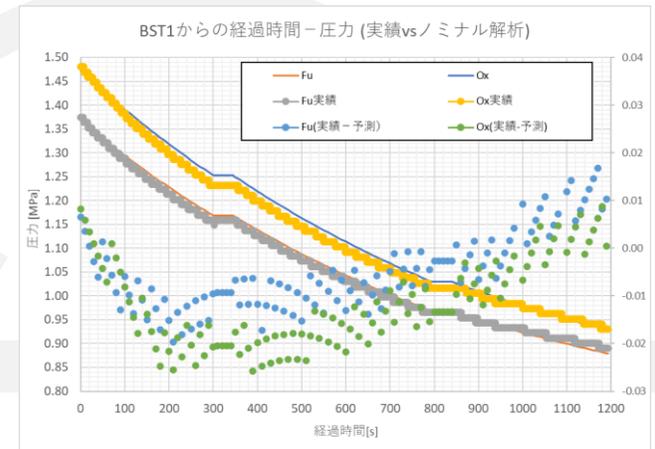
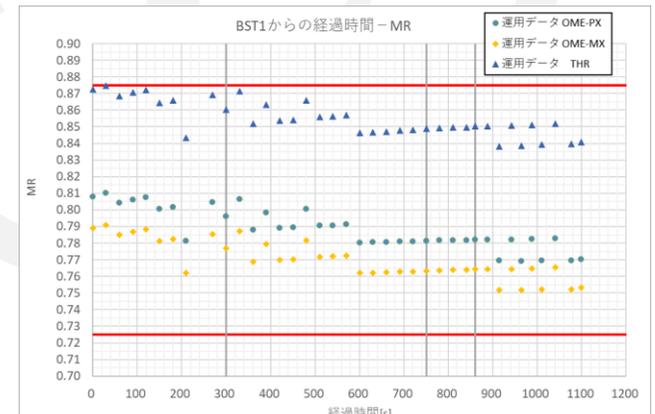
- Example of main engine related data. SLIM uses a blowdown propulsion system, designed to gradually reduce the propellant supply pressure. After launch, the supply pressure of both fuel and oxidizer gradually decrease as propellant is consumed, and the load on the engine also decreases (see top diagram).

- The mixing ratio (MR) of oxidizer and fuel is another important factor that determines the load on the engine, but the MR of the -X side engine is believed to be always lower than that of the +X side engine and therefore, the load on the -X side engine was relatively smaller than that on the +X side engine.

- A total of eight post-launch trajectory changes and the power descent phase have used the main engine under higher supply pressure and higher engine load conditions, but the main engine has not shown any signs of abnormality until just prior to this event.

- Moreover, comparison of the two main engines at the time of the incident suggests that the -X side engine has mild combustion conditions compared to the +X side engine.

- The Project therefore believes that it is highly likely that an external factor and not the main engine itself affected the -X side main engine.
- The cause is still being investigated and there will be further reports when more details are available.

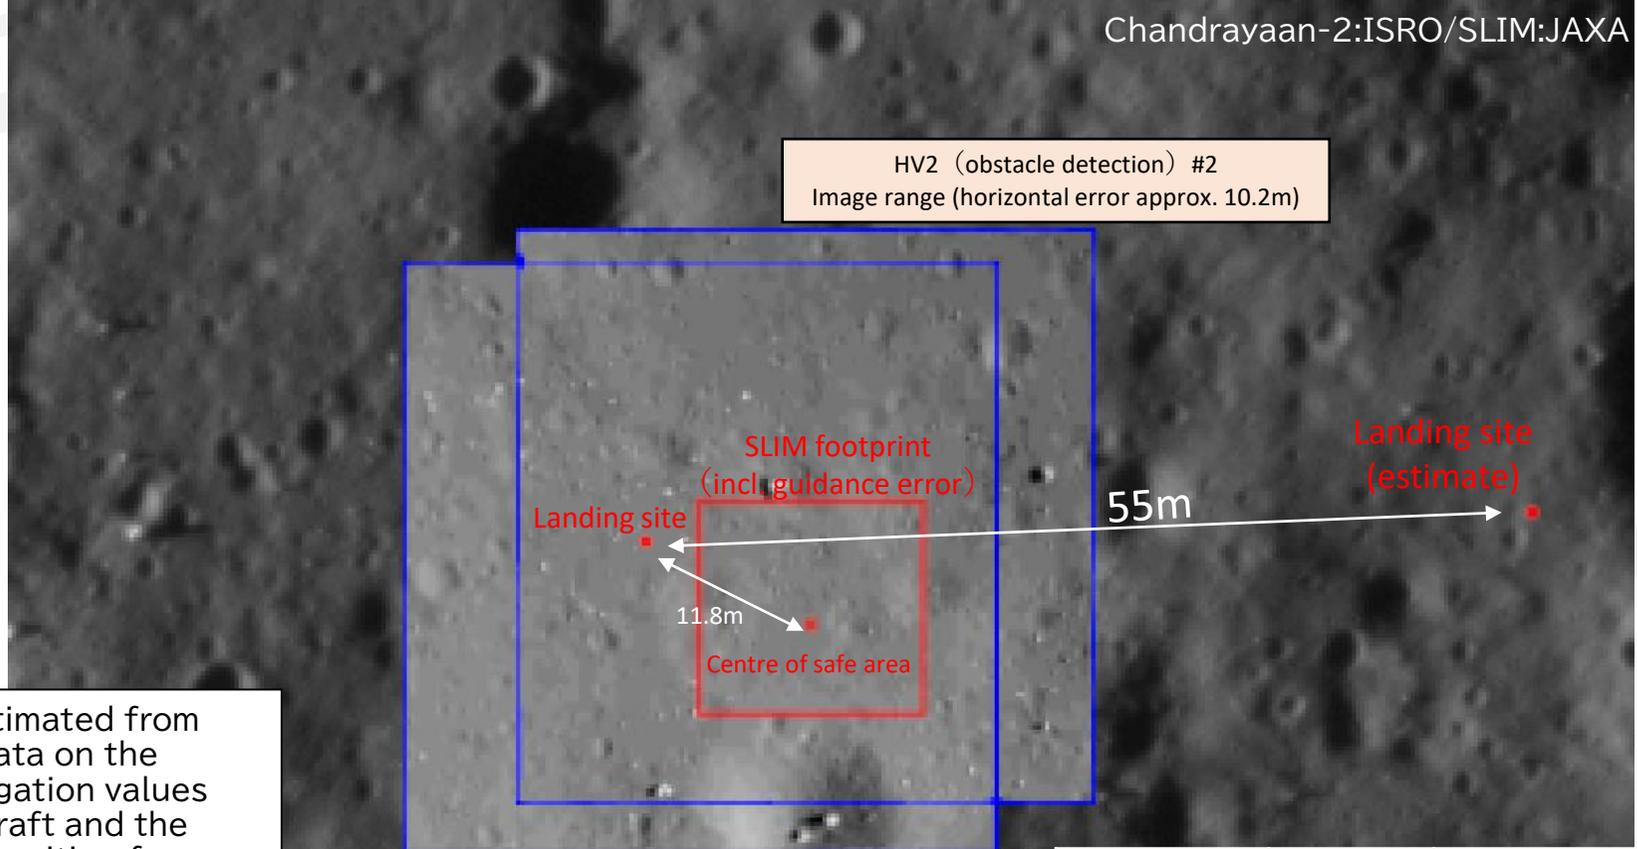
➤ Relationship between the spacecraft position at the time of obstacle detection and the estimated landing point. The spacecraft moved east from its position during its nominal descent (about 55m to the east \*1)

HV2 (obstacle detection) #2  
Image range (horizontal error approx. 10.2m)

\*1 ... Position estimated from the navigation data on the spacecraft. Navigation values from the spacecraft and the later estimated position from this image are generally consistent at the time of the obstacle detection (HV2#1)

Sequence	想定高度	着陸目標点との水平距離
HV2#1	50m	3.4m
HV2#2	50m	10.2m

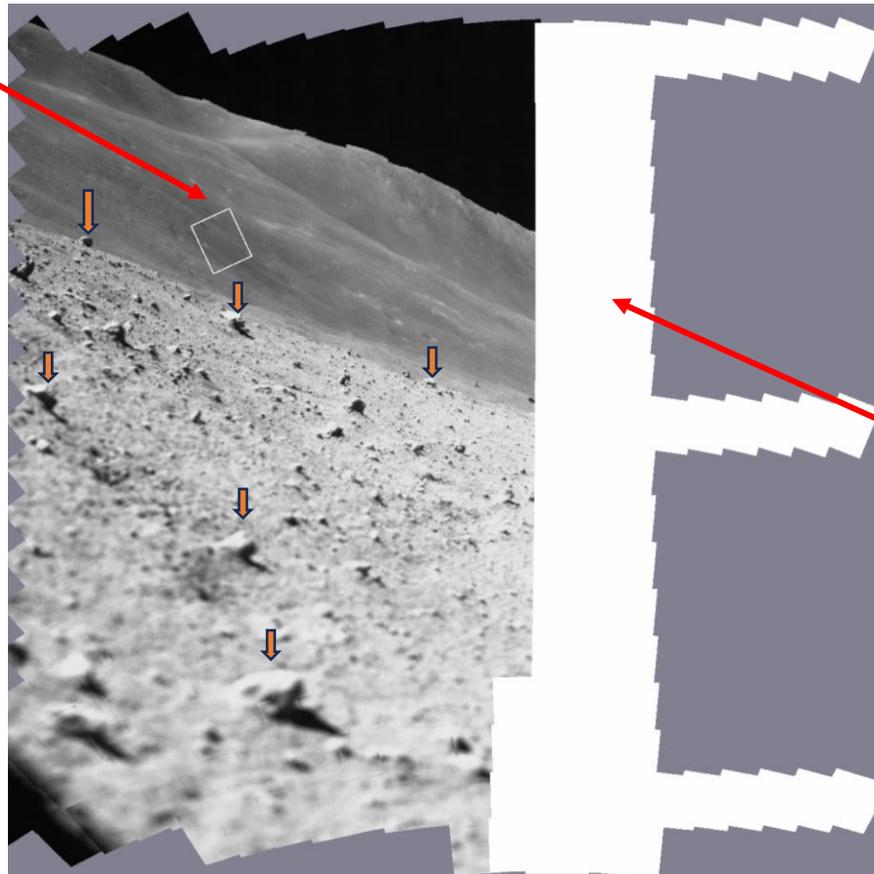
Image mosaic obtained by joining the 257 images from the scan imaging

Originally, the right side of the image should have been in the upward direction.

White areas are without data because the scan was terminated at the half-way point.

↓ Indicate candidate observation sites

- ▶ Launch lock release
  - ▶ Scan imaging
    - ▶ To prevent the temperature of the spacecraft transmitter from exceeding the guaranteed operating temperature, instead of capturing 333 image in 35 minutes, the scan was terminated after 15 minutes. 257 of the 333 images were therefore taken and downloaded.

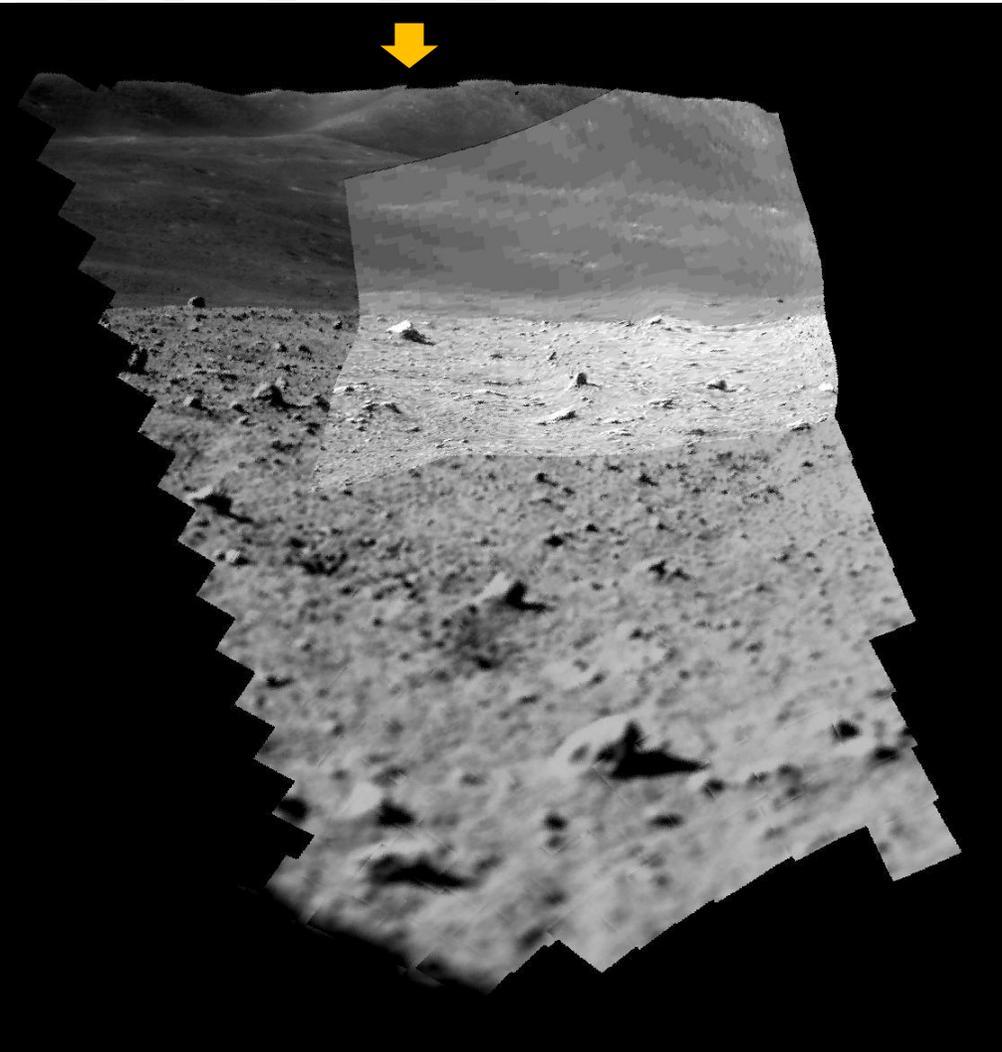
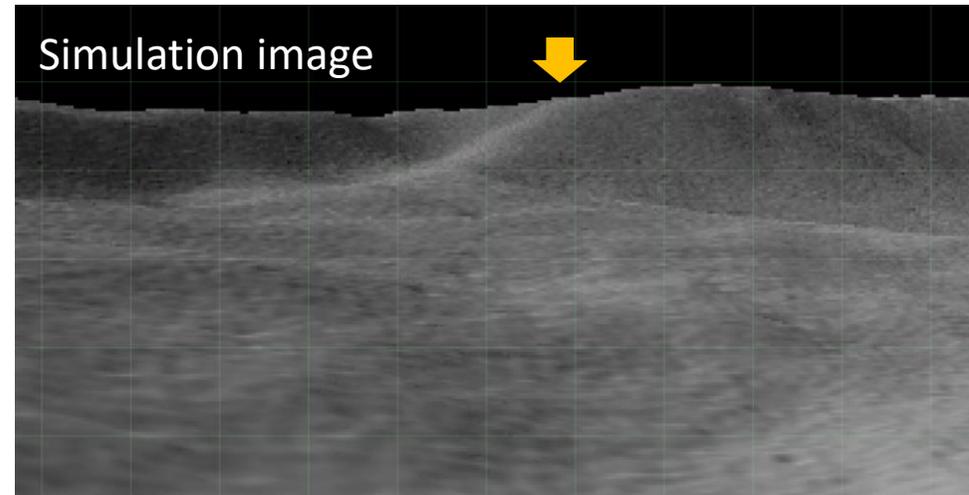
Landscape simulation  
based on DTM of  
KAGUYA TC

Navigation camera (CAM-PX) matching with multi-band spectroscopic camera (MBC) scan images. Slightly whitish area in the upper right is the CAM-PX image
